TECHNICAL REPORT REMR-CO-3

CASE HISTORIES OF CORPS BREAKWATER
AND JETTY STRUCTURES

Report 4

PACIFIC OCEAN DIVISION

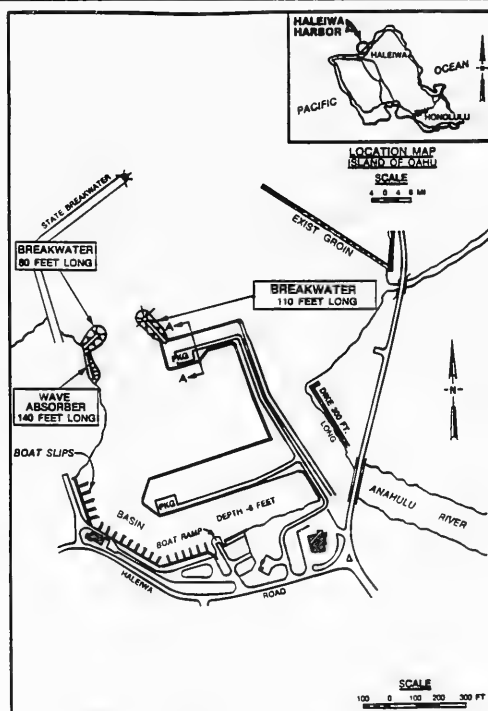
Figure 1. Haleiwa Small-Boat Harbor, Oahu, Hawaii

Date(s)	Construction and Rehabilitation History
1975	The 80-ft-long west and 110-ft-long east breakwaters were added to the existing project at a cost of approximately \$150,000 (Figure 1). The armor stone on the east and west breakwaters (Figure 2) was designed for 6- and 4-ft nonbreaking waves, respectively.
1978	The head of the west breakwater was rebuilt. Failure of the original head was thought to be due to the original structure toes not being placed on a firm foundation, thereby resulting in undermining of the toe and slippage of the armor stone layer. The head was rebuilt with the same size armor stone; but the sand was excavated, and the toe was placed on a firm coral bottom.
1984	Inspection of the stub breakwaters in July revealed that both structures were in good condition.

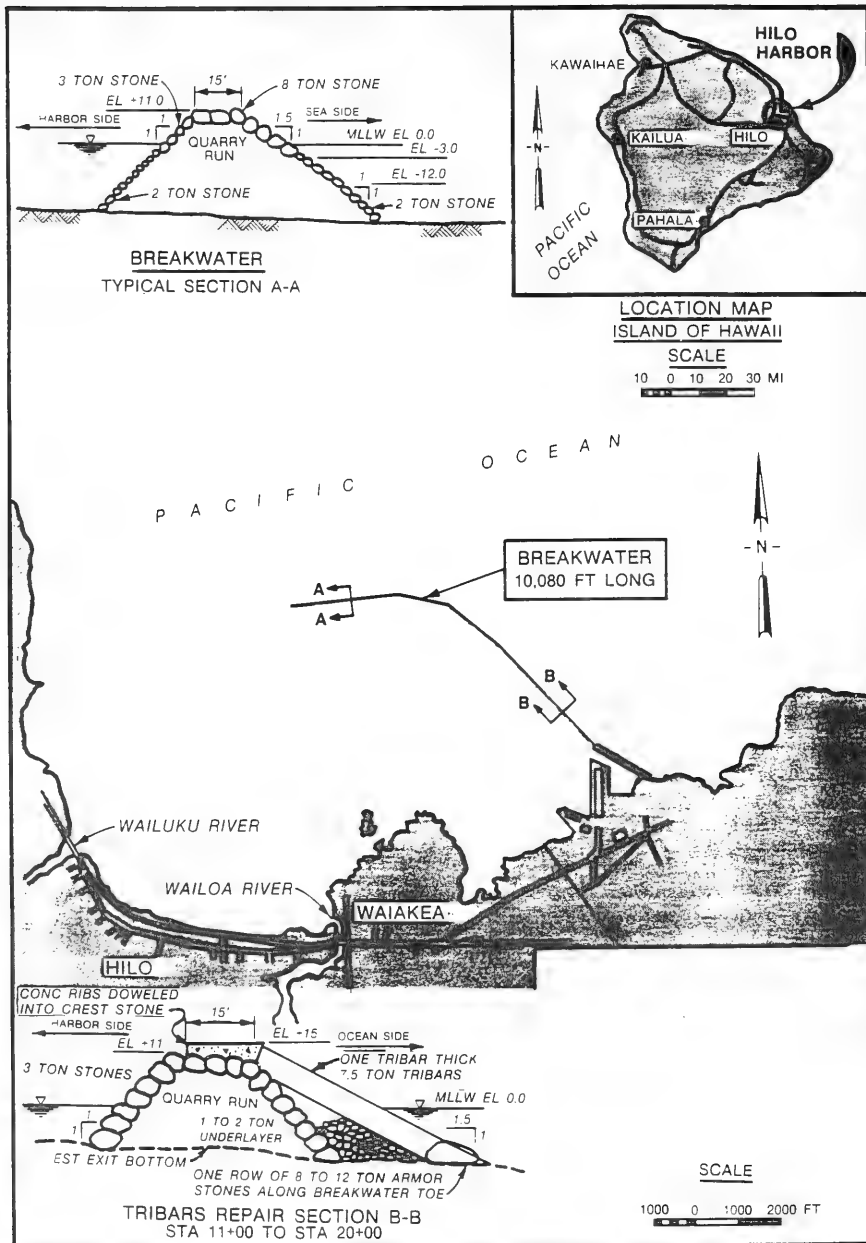
Figure 3. Hilo Harbor, Hawaii, Hawaii

Date(s)	Construction and Rehabilitation History
1930	The Corps completed the 10,080-ft-long rubble-mound breakwater (Section A-A, Figure 3).
1931- 1945	Only minor repairs were required to restore the original construction at an average annual cost of \$10,000 based on 1967 money.
1946	The tsunami of 1 April severely damaged 6,000 ft of the breakwater. Primary armor stone and core material were displaced both seaward and toward the harbor down to an average elevation of -3.0 ft mllw. A 1,100-ft-long breach occurred adjacent to the piers.
1946- 1948	Tsunami damage was repaired using original design criteria at a total cost of \$1,500,000.
1949- 1952	Storm waves of December 1951 caused damage to 13 areas (Figure 4). By October 1952 the structure had been repaired to the original cross section at a cost of \$76,000.
1954- 1957	Storm waves of March 1954 caused damage to several areas (Figure 4). By August 1957 the structure had been repaired to its original cross section at a cost of \$80,000. The structure was exposed to the tsunami of 9 March 1957 but sustained no damage.

1960	The tsunami of 1960 caused breakwater damage (Figure 4), but it was not as severe as that sustained by the 1946 tsunami. Less severe damage was attributed to the direction of wave attack. The 1960 approach was less direct than that of 1946; therefore, wave energy reaching the structure was less than what had occurred in 1946. Between 1946 and 1960 average annual maintenance costs were \$25,000. It was thought that the 1946-1948 repair work did not key the replacement armor into the existing structure, thus resulting in weaker cross sections in these repair areas.
1965	Storm waves of February 1965 caused additional damage at sta 15+00, 36+30, 73+40, 83+00, and 90+00.
1967	Between the 1960 and the 1967 tsunami, no repair work was done due to the possibility of total rebuilding of the breakwater as one leg of a proposed tsunami barrier for Hilo Harbor. The average annual cost of structure maintenance had been \$43,900 for the first 37 years of the project.

1976	Hurricane Kate produced overtopping waves at various lengths of the breakwater on 28 and 29 September. It also was noted that large amounts of water were passing through the structure between sta 6+00 and sta 20+00. An inspection on 5 November 1976 revealed sporadic, moderate damage on the upper sea-side slopes and the crown and harbor-side slopes, but no immediate repairs were recommended.
1977	Inspection on 4 October revealed some settlement of sea-side slope stone in a few areas exposing the crown stone to direct wave attack. In a couple of areas armor stone had been displaced up onto the crown or was missing. No immediate repairs were recommended.
1980	Inspection on 16 October revealed additional sporadic damage to the crown and upper sea-side slope. Damage was not severe but observed transmission through the structure between sta 1+00 and sta 16+00 during heavier seas was thought to be a possible cause of swell conditions in the berthing areas.

Date(s)	Construction and Rehabilitation History
1968	Repair work was completed in August. A total of 11 areas was repaired. Due to the severity of wave overtopping and the recurrence of damage in many areas, the armor stone weight used for repair of the crown was increased from a minimum of 8 tons to a minimum of 10 tons. The remainder of the repair work followed the original cross section design. The total cost of repair was approximately \$124,500.
1971- 1973	An inspection on 7 April 1971 revealed deterioration of the structure at various points along the entire length, but it was thought that immediate repair of 1,700 ft at the shoreward end of the structure was needed to protect the berthing area. Emergency repair work was completed in 1973 at a cost of \$184,000. The original cross section design was used for repair.
1975	Major repair of the breakwater was completed. Both new and reset 8- and 10-ton minimum weight armor stones were used to repair various areas along the entire length of the structure. The structure slopes and crown elevation were unchanged from the original design cross section. The total cost of the work was approximately \$591,000.

Date(s)	Construction and Rehabilitation History
1981	<p>The breakwater was repaired between sta 11+00 and sta 20+00. One layer of uniformly placed 7.5-ton tribars extended from sea-side toe to crown on a 1V:1.5H slope. The tribar toe was buttressed with a single row of 8- to 12-ton stone, and concrete ribs were constructed on the crown (Section B-B, Figure 1). The design was based on a 15.5-ft water depth, a breaking wave height of 13.5 ft, and a K_D of 7.5. Excess tribars were stockpiled in a single layer on the seaside of the breakwater shoreward of the repair site.</p>
1984	<p>During a 2 August inspection by US Army Engineer Waterways Experiment Station (WES) personnel, it was noted that the tribars seemed to be on a steeper than 1V:1.5H slope in some areas. No broken armor units were seen during the inspection. Inspection only went to sta 40+00, but just beyond the tribar repair area damage to upper sea-side slope and crown armor stones was noted in a couple of areas. The tribar repair is in good condition. The old armor stone structure is in need of some repair and will continue to need repair as long as the repair work continues to be done with the original size armor stone. Although the maximum wave heights that the structure has seen are unknown, it is exposed to large wave conditions on a regular basis.</p>

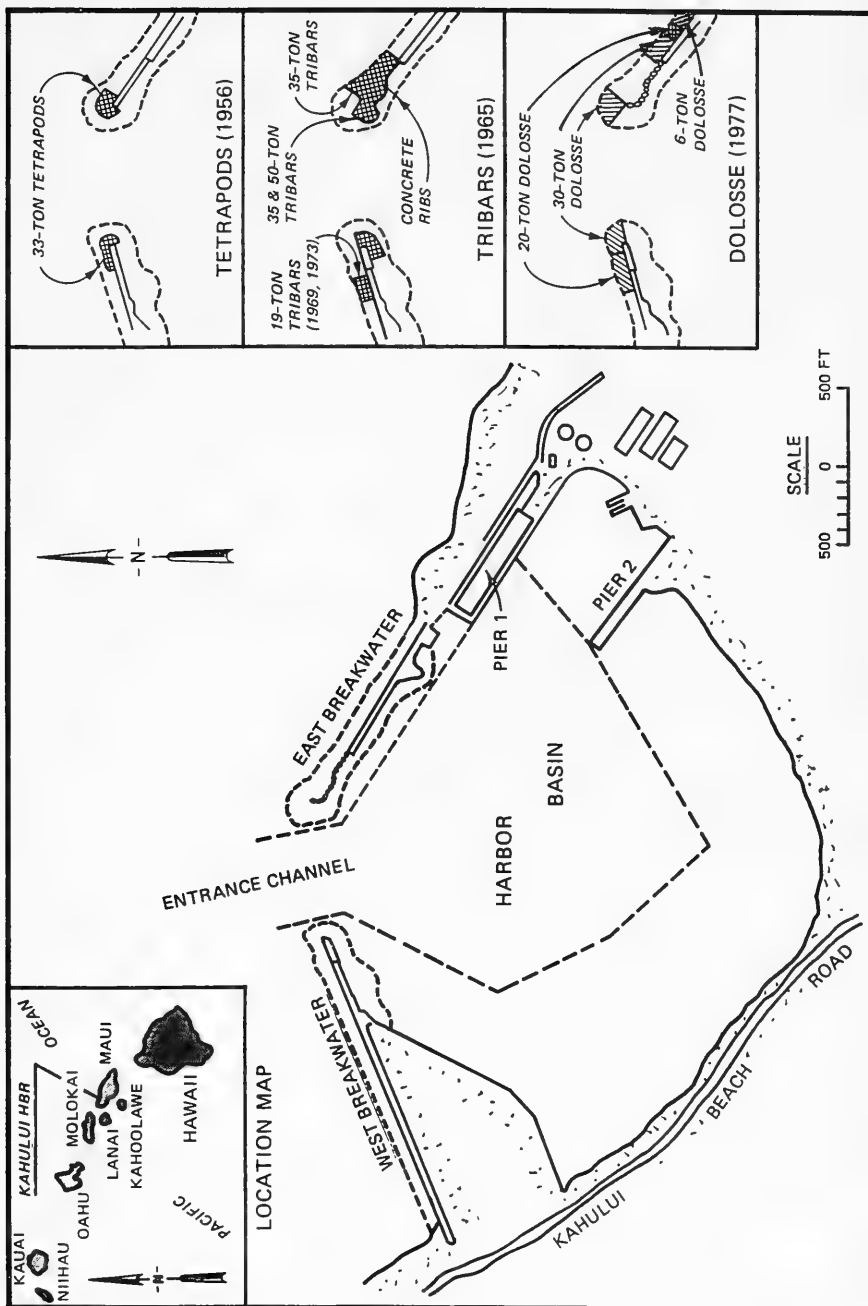
Figure 5. Kahului Harbor, Maui, Hawaii

On 14-17 October 1943 the east breakwater was damaged. Approximately 45 tons of rock on the extreme east end were dislodged and washed into the inner harbor area. Approximately 150 ft shoreward of the east breakwater light a larger mass of stone was dislodged and washed into the harbor. This break was on the inside of the east breakwater and covered an area approximately 75 ft long and 20 ft deep. The Estimated repair quantity was 250 tons.

1977	<p>A 1973 breakwater inspection indicated considerable damage and settlement of the 33-ton tetrapods on the seaward quadrants of both breakwater heads. In addition, the 8-ton armor stone along both trunks was failing and required repair. In 1977 the following repairs were completed (Figure 5): on the west breakwater, 257 30-ton reinforced dolosse were placed in two layers over the 33-ton tetrapods on the sea-side quadrant of the head; 291 20-ton reinforced dolosse were placed on the sea-side slope of the west breakwater trunk; on the east breakwater 610 30-ton reinforced dolosse were placed in two layers over the 33-ton tetrapods on the sea-side quadrant of the head; 164 20-ton reinforced dolosse were placed in a double layer on the sea-side slope of the trunk beginning at the shoreward end of the 35-ton tribars; and, beginning at the point where the 20-ton dolos ended and extending shoreward, two layers of 6-ton unreinforced dolosse (455 units) were placed on the sea-side slope of the east breakwater trunk. The total cost was \$3,290,000.</p>

Date(s)	Construction and Rehabilitation History
1969	<p>The damaged west breakwater trunk was repaired by placement of two layers of 19-ton reinforced tribars (260 units) on the sea-side slope, shoreward of the tetrapod area (Figure 5). A concrete rib cap was added to the crest for buttressing of the tribars. The total cost was \$443,000.</p> <p>In November 1969 another severe storm hit with estimated breaking wave heights of 15-20 ft; damage occurred to the west breakwater in the tribar-original armor stone transition area, presumably because of insufficient interlocking. Approximately 25 19-ton tribars were moved shoreward as much as 300 ft.</p>
1973	<p>The November 1969 damage was repaired by placement of 80 19-ton reinforced tribars (Figures 5 and 10). The tribars and concrete crest ribs were extended shoreward another 80 ft down the seaside of the west breakwater trunk, and the landward end of the tribar armor section was buttressed by 25 35-ton tribar units. The total cost was \$262,000.</p>

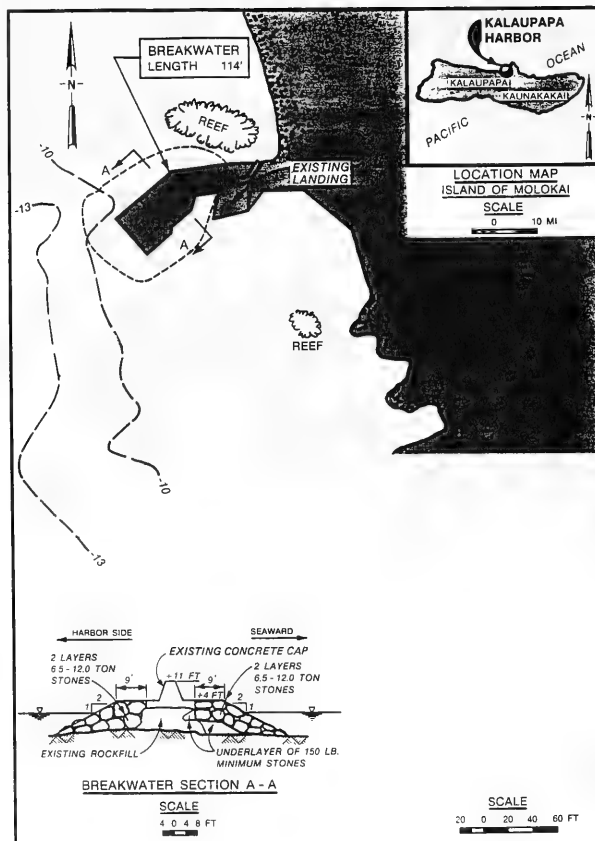
Figure 12. Kalaupapa Harbor, Molokai, Hawaii

Date(s)	Construction and Rehabilitation History
1967	<p>An existing rock fill breakwater with a concrete cap was improved by widening the crown and armoring the structure slopes with 6.5- to 12-ton armor stone (Figure 12). The armor stone was designed for a 12-ft breaking wave in a water depth of 15 ft at the breakwater head. The breakwater modification cost approximately \$95,000. As of 1984, the structure has required no major maintenance.</p>

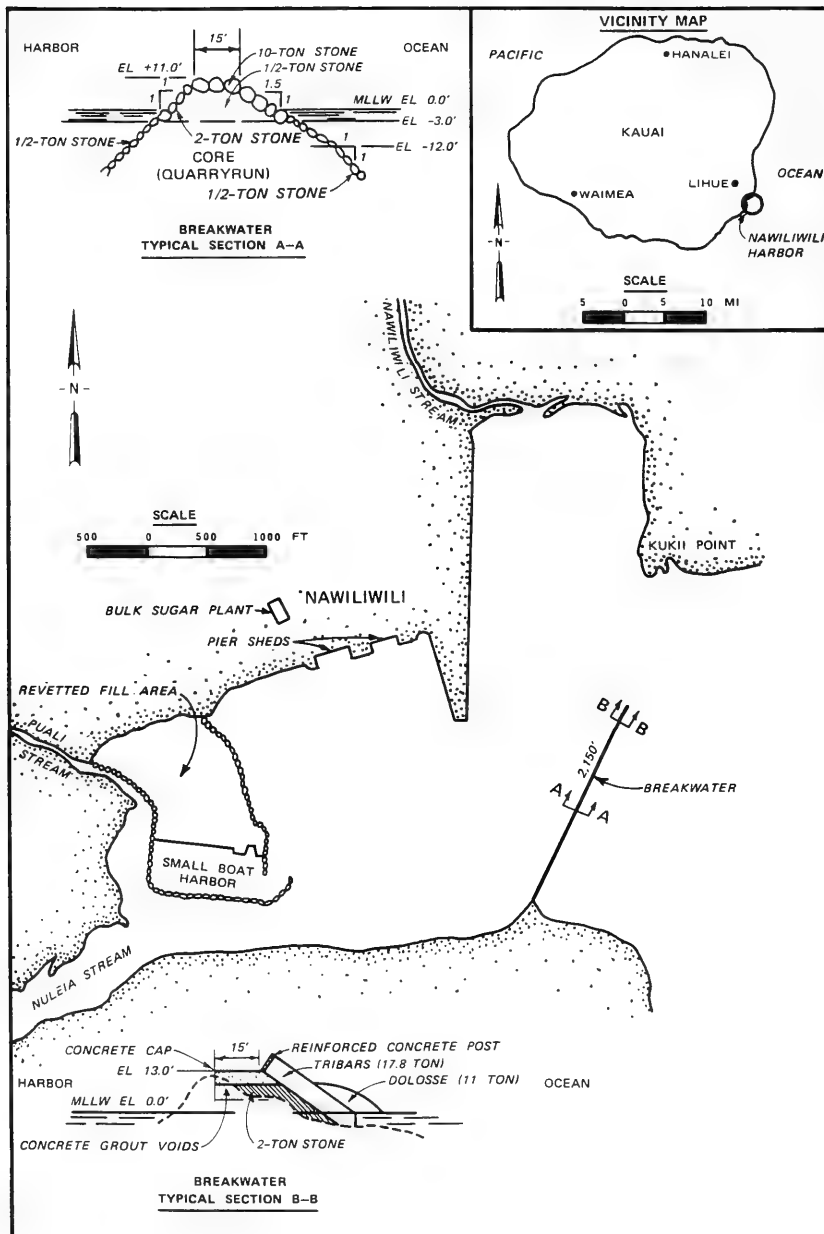
Figure 15. Nawiliwili Harbor, Kauai, Hawaii

Date(s)	Construction and Rehabilitation History
1926	The original Corps-constructed (Figure 15) 2,150-ft-long rubble-mound breakwater was completed (construction started in 1922). It consisted of one-layer 8-ton keyed and fitted armor stone over core stone (500 lb and less) with 1-V:1-H slopes and a 15-ft-wide crown at +11.0 ft mllw. Except for severe wave action, it was considered to be a satisfactory empirical design cross section.
1927- 1953	Minor repair work was done at various times during this period. In 1931 114 stones were reset, and 3,153 tons of stone and concrete blocks were placed (no details available) at a cost of \$46,040. In 1930, 1932-37, 1945, 1951, and 1952, 1,998 tons of stone were used in repair work at a total cost of \$78,285. Details of the repair work were not found.
1954- 1957	The breakwater was severely damaged as the result of a storm in 1954 (hindcasted depth-limited breaking wave height of 24 ft at structure) which destroyed the head, washed 100 ft of core stone shoreward, and settled capstone to an elevation of a few feet below mllw with little lateral movement. Storm waves displaced armor stone and exposed and removed core material between sta 17+50 and sta 20+45 in 1956. Observed wave heights of 16 ft at the breakwater in September 1957 caused additional armor stones and core displacement between sta 16+00 and 20+45 and displacement of a few armor stone and core exposure between sta 14+00 and sta 16+00. Hydrographic and topographic surveys of January 1958 revealed that Hurricane Nina (depth-limited breaking waves at structure on 1 and 2 December 1957) displaced a few armor stones and exposed core material on the sea-side slope between sta 14+00 and sta 15+00. It also caused settling and raveling of all armor stone on the crown and sea-side slope between sta 15+00 and sta 20+20, resulting in an exposed core and large voids between armor stones and all armor stone and core above mllw (sta 19+25 to sta 19+50 and sta 20+20 to sta 20+45) which was displaced shoreward.

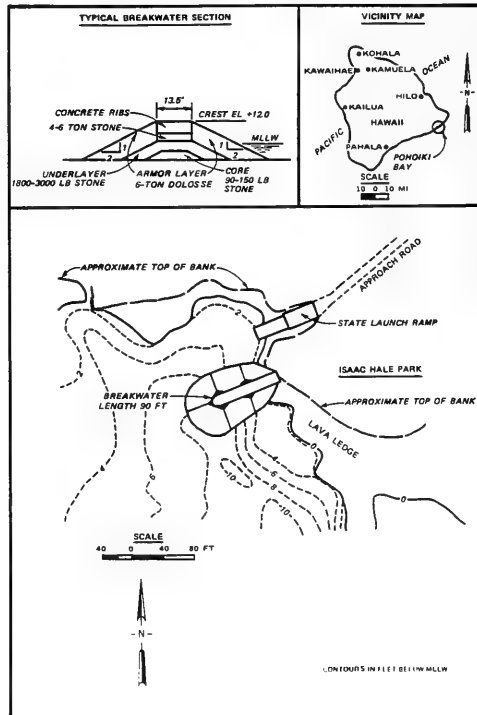
Figure 19. Pohoiki breakwater, Hawaii, Hawaii

A 90-ft dolos-armored structure with a concrete rib cap was constructed in 1979 at a cost of approximately \$335,500 (Figure 19). The structure was designed for 12-ft depth-limited breaking waves at the structure. The wave condition has reportedly occurred on several occasions since completion of construction, and the structure shows no signs of deterioration. The 6-ton unreinforced dolosse (two layers) exceeded the needed weight for the design conditions but were found to be more economical than a lighter weight in that fewer units were needed. All existing dolosse breakage (5 units) occurred during construction and were left on the structure. Figure 20 is an aerial photograph of the breakwater taken in 1984.

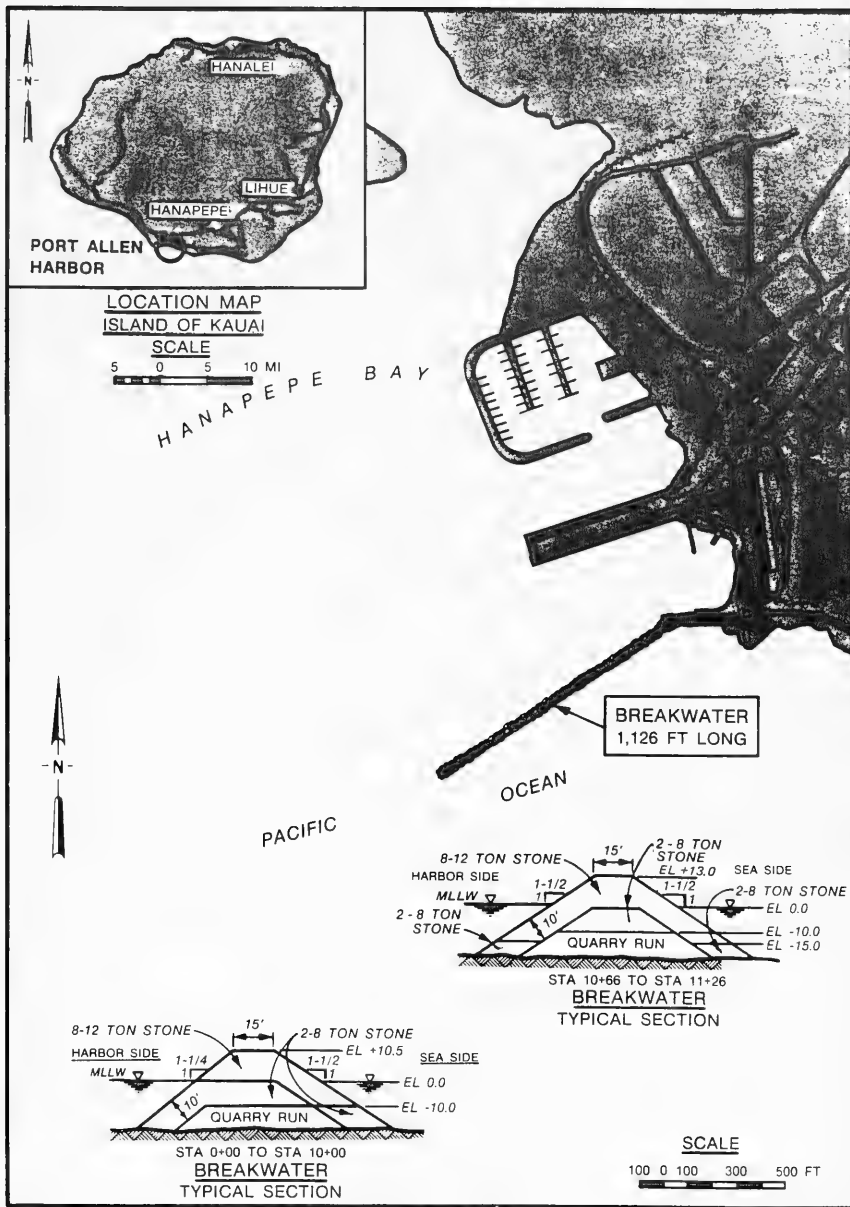
Figure 21. Port Allen Harbor, Kauai, Hawaii

<u>Date(s)</u>	<u>Construction and Rehabilitation History</u>
1935	The 1,200-ft-long structure was completed as an extension to a privately constructed breakwater (Figure 21).
1982	Until damaged by Hurricane Iwa of November 23, the old 8-ton keyed-and-fitted armor stone structure had no repair history. The breakwater light at the seaward end had been damaged and repaired several times (Coast Guard cost) prior to its present destruction. The estimated 20-ft breaking waves at the structure first dislodged the stones on the inboard crest which eventually resulted in the total destruction of the outer 130 ft of the breakwater. Overtopping waves also displaced crest stone and exposed under-layer stone on a 150-ft length at the extreme root of the structure. Minor damage also was sustained along the inboard slope.
1984	The head was rebuilt, and the minor damage on the inboard slope was repaired at a cost of \$178,000. The breakwater was shortened to a total length of 1,126 ft. The outer 74 ft was abandoned. The repair was accomplished by resetting stone remaining on the structure and by retrieving stone from the harbor and replacing it on the structure using the old keyed-and-fitted construction (Figure 22). The crown elevation on the last 80 ft of structure was increased to +13.0-ft mllw. This was done to improve the stability of the inboard slope by decreasing wave overtopping. The root of the breakwater was not repaired.

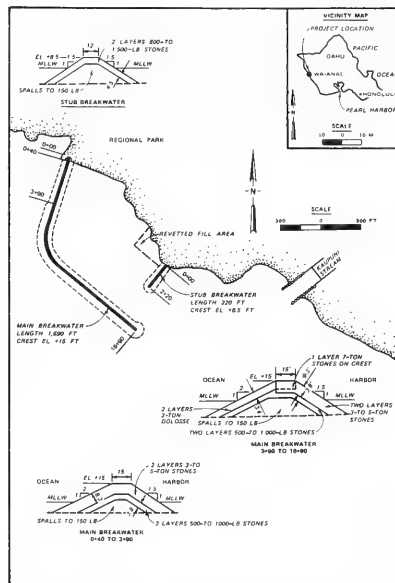
Figure 23. Waianae Small-Boat Harbor, Oahu, Hawaii

Date(s)	Construction and Rehabilitation History
1979	The 1,690-ft-long armor stone and dolosse-armored main breakwater and 220-ft-long armor stone stub breakwater were completed in January (Figure 23). The dolosse-armored portion of the main breakwater was model tested (Bottin, Chatham, and Carver 1976) for a design breaking wave height of 11.8 ft in a water depth of 16 ft.
1980	Inspection of the structure revealed that 203 of the 6,633 dolosse originally placed were broken. It is estimated that 47 of these were broken and left in place during construction.
1982	Inspection subsequent to Hurricane Iwa of November 23 revealed no additional breakage of dolosse, but it is thought that a section of dolosse around sta 4+00 may have slumped slightly.
1984	The structures looked in good condition during a 7 August 1984 inspection. Dolos breakage appeared unchanged from 1980, and the slump area referred to above did not appear to pose any immediate problem. There was no obvious need to implement breakwater repair.

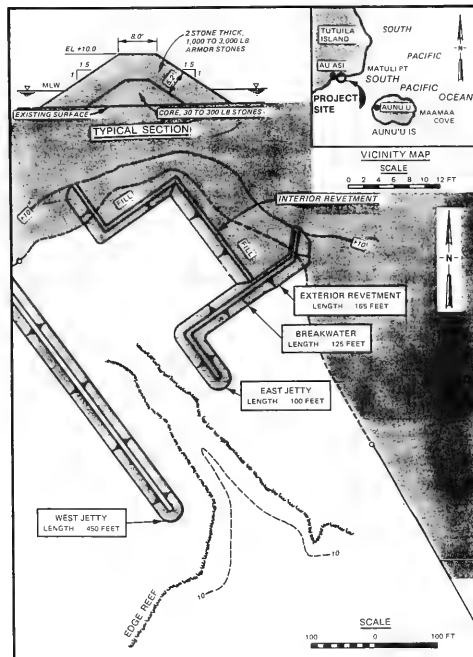
Figure 24. Auasi Small-Boat Harbor, Tutuila Island, American Samoa

Date(s)	Construction and Rehabilitation History
1981	<p>A 125-ft armor stone breakwater and 100- and 450-ft east and west armor stone jetties, respectively, comprised a portion of the project completed in 1981 (Figure 24). Total cost of the project was approximately \$1,166,300. The structures were designed for depth-limited breaking wave heights of 4.8, 7.0, 5.6, and 6.0 ft for the breakwater, west jetty head, west jetty trunk, and entire east jetty, respectively. Water depths for these wave heights were 6.2, 7.2, 7.2, and 7.7 ft, respectively. The structures have no history of damage or repair. There is some evidence of armor stone breakage. Although quarried basalt armor stone appeared to be free of cracks when placed, internal stresses may be responsible for breakage. Testing by dropping from a 10-ft height onto a stone bed did not result in breakage during construction. The condition is not widespread and is not considered serious at present.</p>
